Performance Assessment of Two Different Aviation CARC Coating Systems on Steel When Cadmium Plating Is Eliminated

ARL-TR-4136

June 2007

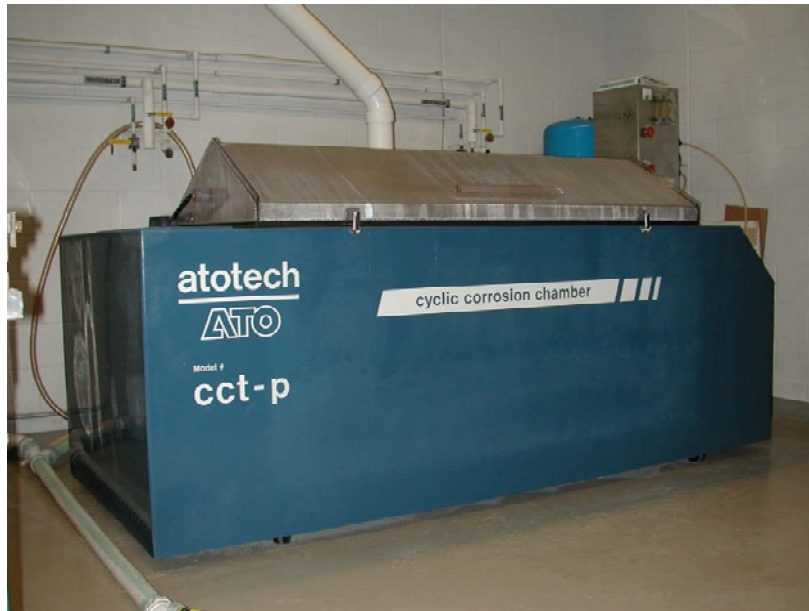
Figure 1. Test chamber configuration used for GM 9540P cyclic corrosion.

Table 1 presents the identification scheme used throughout this study. With the exception of the adhesion specimens, all groups utilized GM 9540P (6) accelerated cyclic corrosion to produce the corrosive conditions. The GM 9540P exposure was conducted in a cyclic-corrosion chamber from Atotech (shown in figure 1). The GM 9540P test consisted of 18 separate stages, including saltwater spray, high humidity exposure, drying, an ambient dwell, and elevated temperature heated drying. The environmental conditions and duration of each stage for one complete GM 9540P cycle are provided in table 2. A standard GM 9540P test solution consisting by weight of 0.9% NaCl, 0.1% CaCl₂, and 0.25% NaHCO₃ was used. In addition, the cyclic chamber was calibrated with standard steel mass-loss calibration coupons, as described in the GM 9540P test specification.

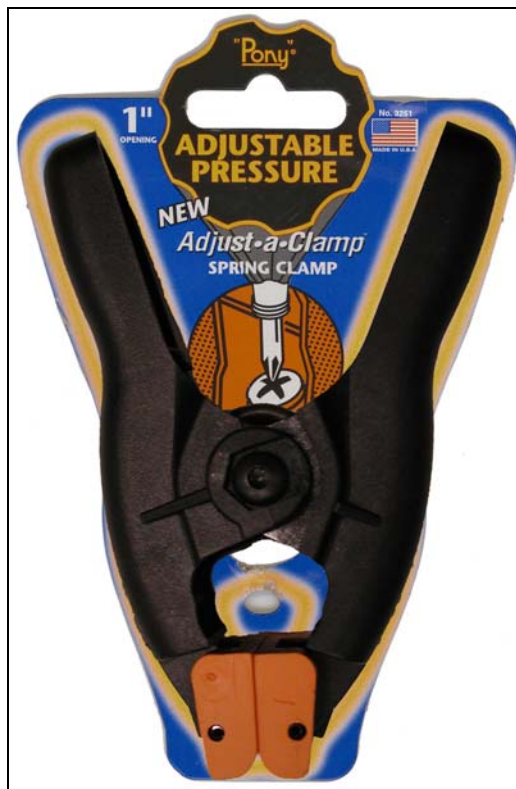
Figure 2. Adjustable clamp used for sandwich assemblies in crevice corrosion.

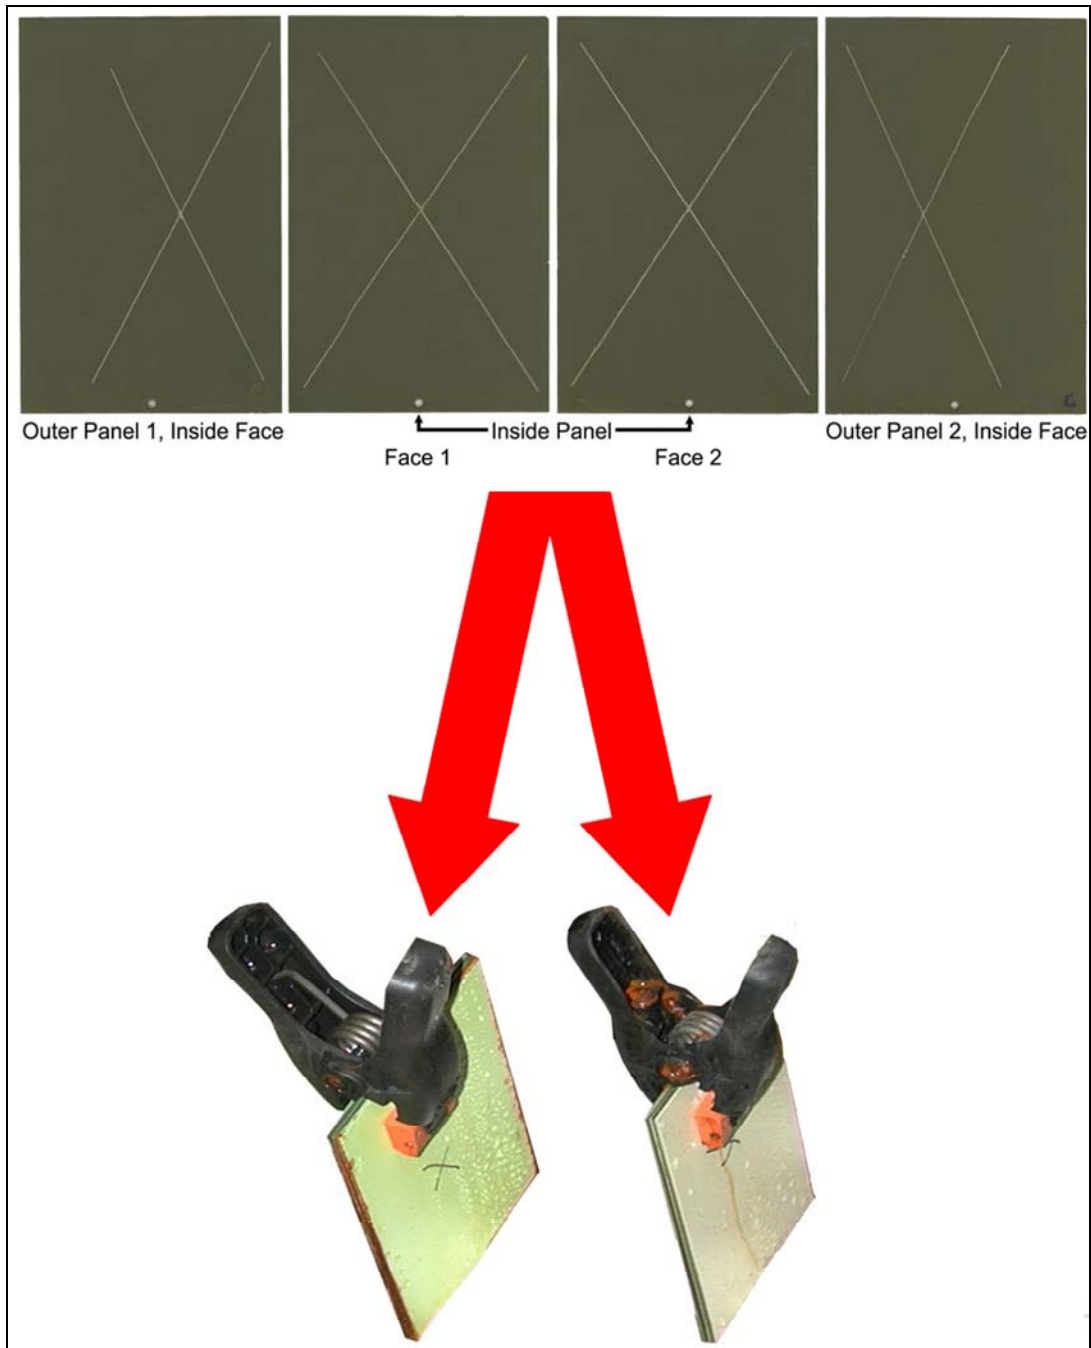
Figure 3. Crevice-corrosion sandwich-assembly configuration showing scribe layouts and chromated and nonchromated assemblies.

Crevice corrosion was evaluated using sandwich-type specimen configurations. The sandwich configurations used panels and coating configurations identical to the general corrosion, but with three panels comprising one complete specimen sandwich. The sandwich specimens were arranged with the panels' test faces directly contacting each other. Two outer panels with one side fully prepared faced a third inner panel with both sides fully prepared. The outside faces of the two outside panels were only primed (not topcoated), which facilitated easy identification by using different pigments for the chromated and nonchromated primer formulations. The sandwich crevice-corrosion method examined damaged and undamaged conditions

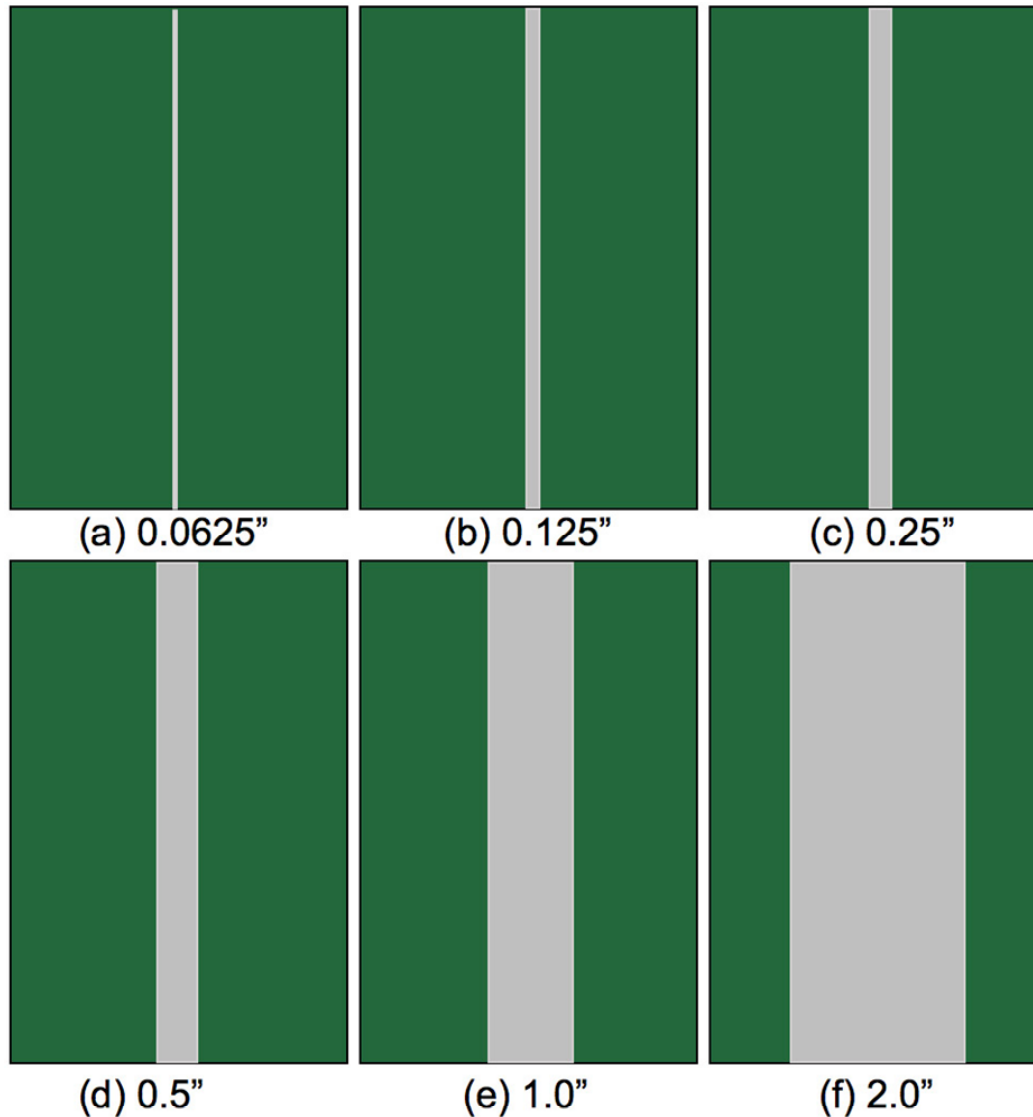
Figure 5. Throwing-power-panel experimental configuration showing widths of primer- and topcoat-free areas.

Throwing-power test panels, with and without Cd plating, were prepared by masking the centers with single strips of vertically arranged tape in a range of widths (0.0625, 0.125, 0.250, 0.5, 1, and 2 in as shown in figure 5). With the masking tape in place, five replicates of each panel were sprayed in the standard manner. In addition, five replicates for each thickness and primer were prepared without MIL-DTL-64159 topcoat. After the standard cure, the panels were exposed

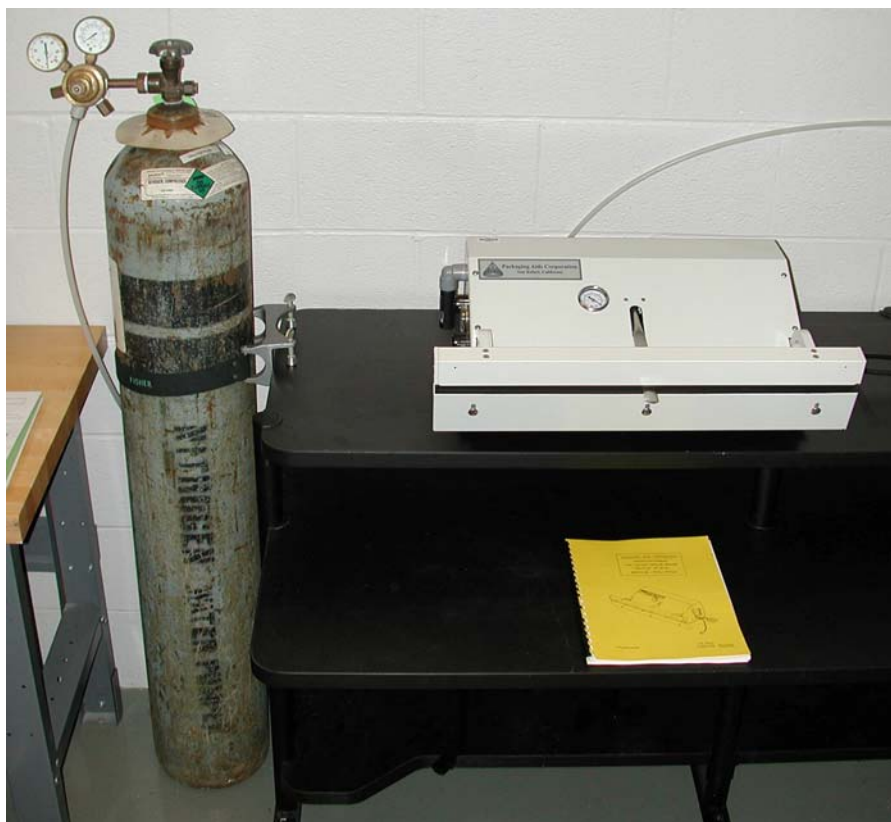
Figure 6. Tabletop vacuum impulse sealer with nitrogen backfill (Packaging Aids Corporation, series 88).

However, they were immediately vacuum-evacuated and backfilled with laboratory pure nitrogen gas in poly-nylon bags (Jetplate) using a tabletop vacuum impulse sealer (Packaging Aids Corporation, series 88) shown in figure 6. These packaged sets were allowed to dwell for time intervals corresponding to the open-air panels and were primed simultaneously with the open-air sets using the standard coating systems from this study. Additional sets of Cd-plated panels and unplated steel with unmodified mill finish were solvent-wiped with acetone, primed, and topcoated. No other surface treatments were applied. An hydraulic adhesion tester (Elcometer, model 108) was used for this procedure. In addition to being a more quantitative test method, pull-off adhesion is also less prone to human subjectivity, i.e., variations in pressure applied during scribing and interpretation and perception of results. For the pull-off adhesion test, a loading fixture commonly referred to as a dolly is secured normal to the coating surface

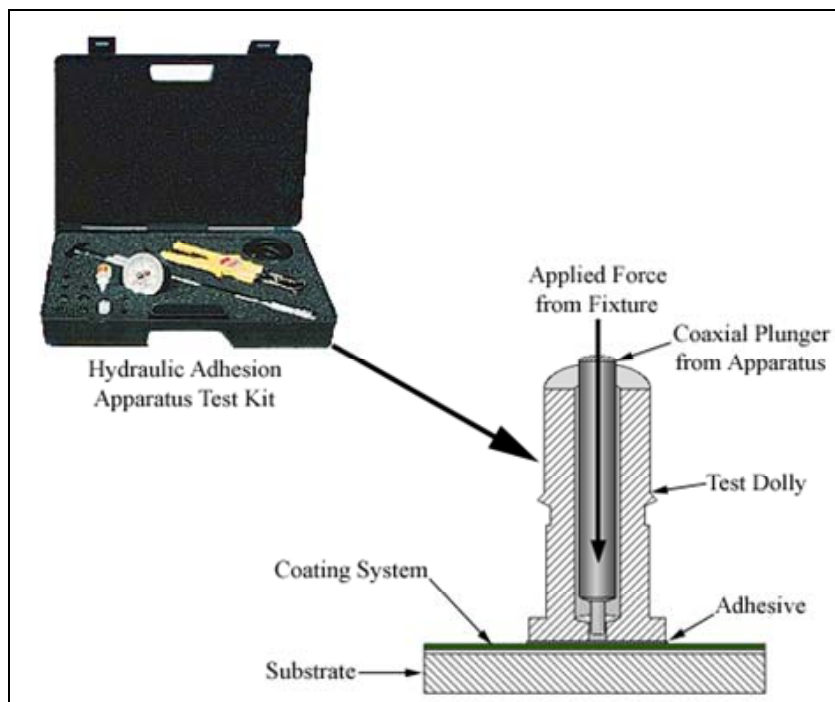
Figure 7. Pull-off hydraulic adhesion test (ASTM D 4541).

The load applied by the apparatus was gradually increased and monitored on the gauge until a plug of coating was detached. The failure tension in pounds per square inch and the failure mode and location within the coating system were recorded. The pull-off test apparatus and dolly configuration are illustrated in figure 7. For pull-off data to be valid, the specimen substrate must be sufficiently thick to ensure that the coaxial load applied during the removal stage does not distort the substrate material and cause a bulging or “trampoline effect.” When a thin specimen is used, the resultant bulge causes the coating to radially peel away from the center instead of being uniformly pulled away in pure tension and, thus, results in significantly lower readings for identically prepared specimens at greater substrate thickness. At 0.12 in, the panels were adequately thick for valid pull-off test results. For each set of three replicates, a minimum of 42 pull-off readings were collected. Only clear adhesive or cohesive pull-off tension values within the coating system or at the substrate were reported. Measurements for samples with cohesive or adhesive failure of the cyanoacrylate adhesive above the topmost coating surface were rejected. A complete overview and description of the adhesion matrix, including panel designation, is provided in table 7.

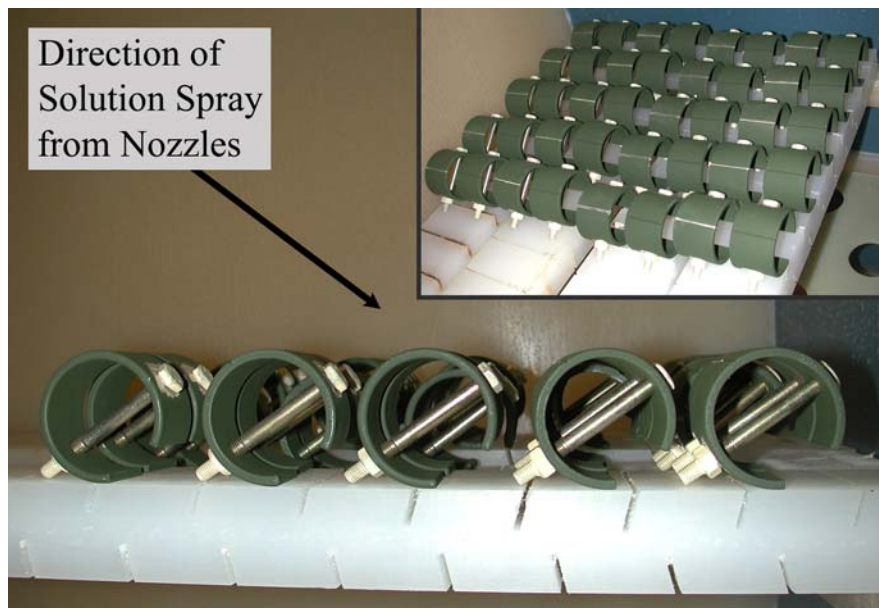
Figure 8. Damaged and undamaged 1d C-ring specimens arrayed in test chamber for GM 9540P exposure.

GM 9540P cyclic corrosion with the notched toward the chamber spray nozzles to ensure an unobstructed angle of the GM 9540P spray solution (figure 8). When exposure commenced, the C-rings were monitored for failure. When specimen failure was detected, the C-ring was removed and the GM 9540 cycle was recorded.

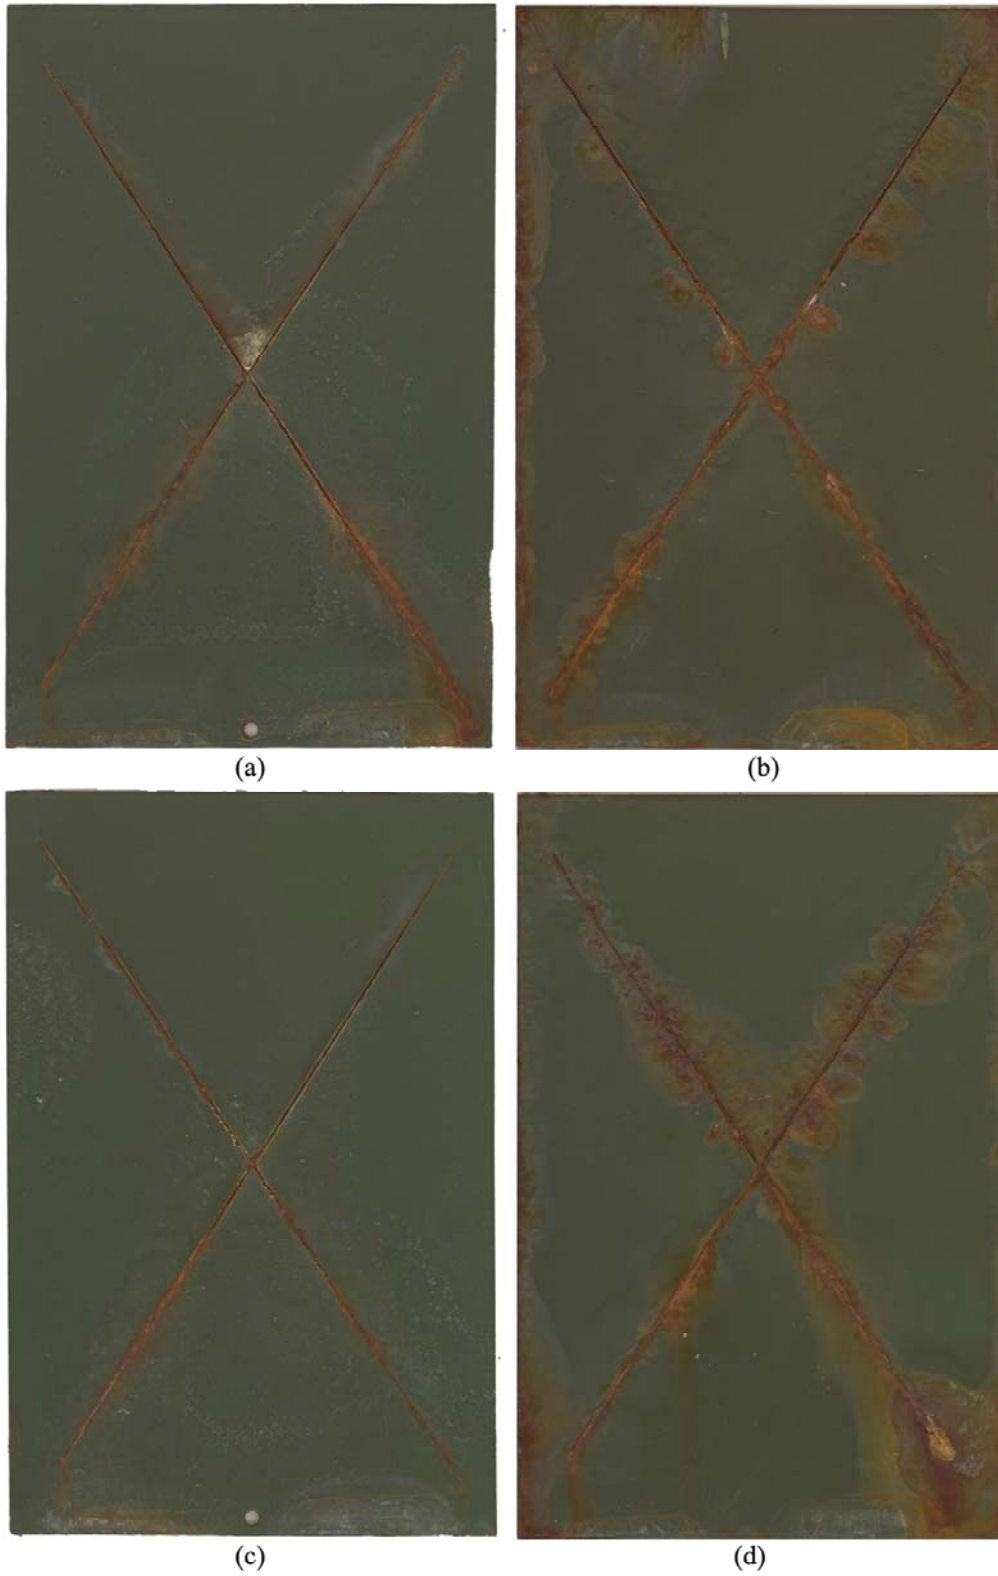
Figure 9. GM 9540P results for scribed general corrosion showing (a) 80 cycles with coating system 1, (b) 50 cycles with coating system 2, (c) 80 cycles with coating system 3, and (d) 50 cycles with coating system 4.

As expected, the general-corrosion panels exhibited major variations in performance that depended on the coating system used. The 1G system, consisting of Cd plating with the MIL-PRF-23377 class C primer, performed the best for scribed 4130 panels. This particular system showed no damage beyond the initial scribe damage until 40 GM 9540P cycles and showed absolutely no red rust up to the 30-cycle observation. Three of the five panels went the full 80-cycle duration without total failure from scribe creepback. The next best performance was from 3G, comprised of Cd plating with MIL-PRF-23377 class N primer. The 3G system was, with one exception, worse than the 1G system for every replicate; however, 3G had much better performance than the 2G and 4G cadmium-free systems. The 2G and 4G performances were comparable—there was no apparent benefit from 2G's use of the chromated primer formulation. Figure 9 presents results typical for the different scribed coating systems with nonchromated specimens terminated well before 80 cycles from severe corrosion damage. All of the coating systems performed well in the unscribed configuration, went the full 80 cycles of GM 9540P with perfect 10 ratings, and exhibited no blistering or rust. It should be noted that although edge areas of the test panels were not rated, there was significantly more damage from rusting and edge creepback for the Cd-free coating systems (figure 10). Tables 10 and 11 give complete ASTM D 3359 ratings and observations of first red rust (designated with an asterisk) for all general-corrosion specimens (refer to table 3 for rating guide).

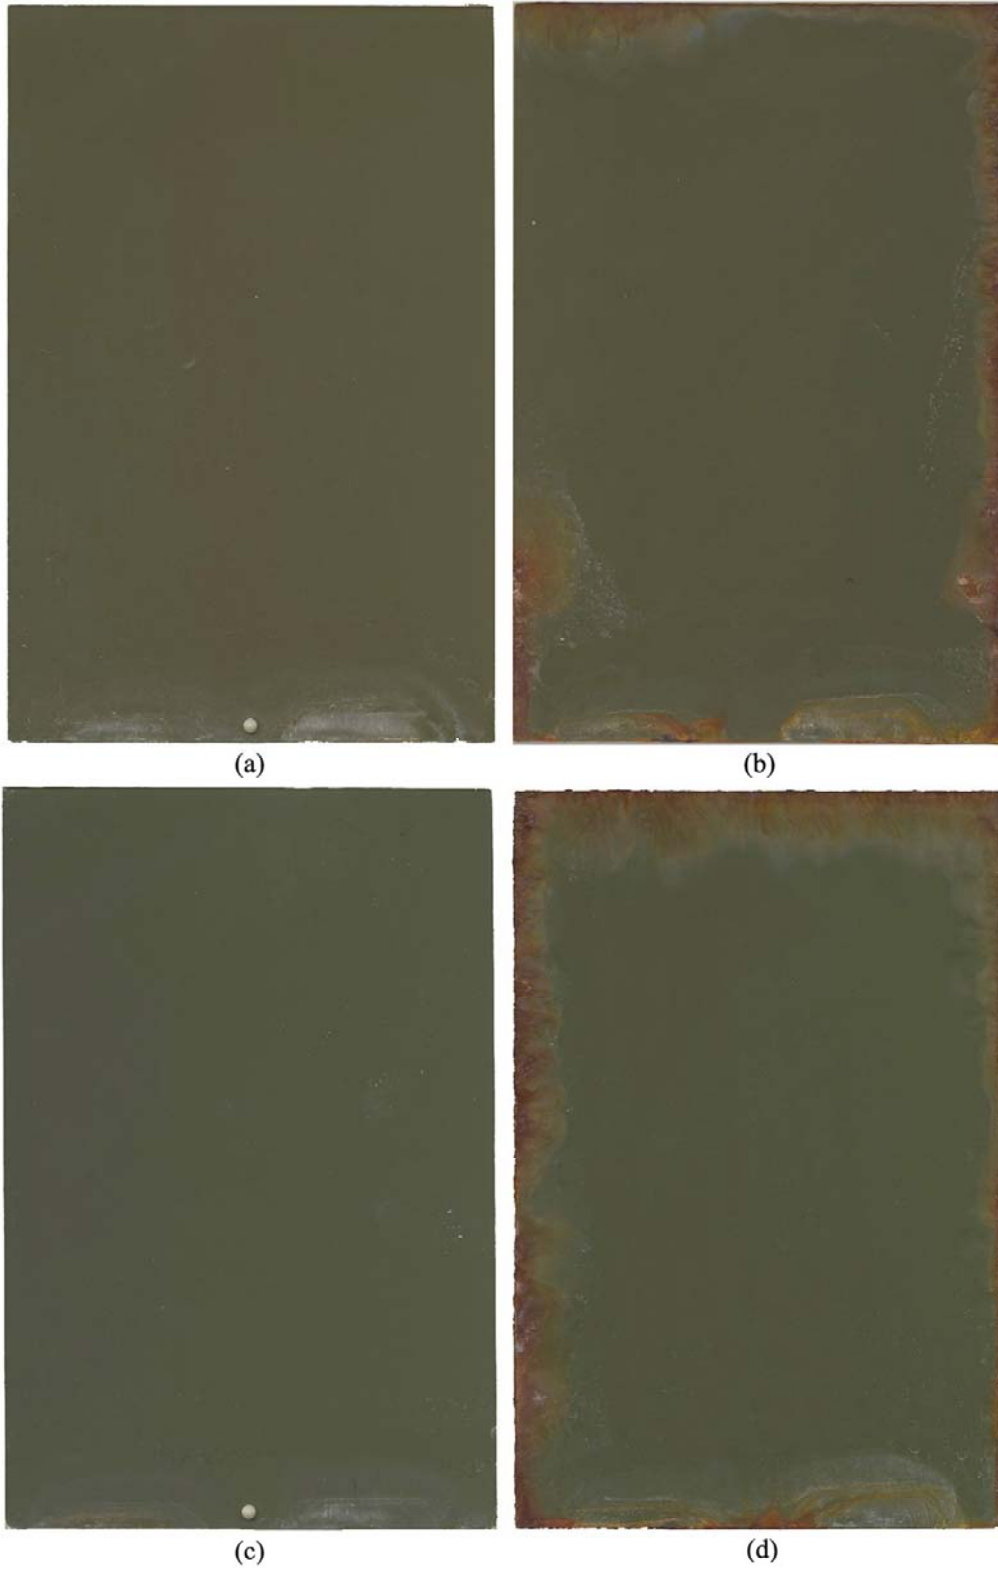
Figure 10. The 80-cycle GM 9540P results for unscribed general corrosion showing relative corrosion attack amounts at the edges for coating systems (a) 1, (b) 2, (c) 3, and (d) 4.

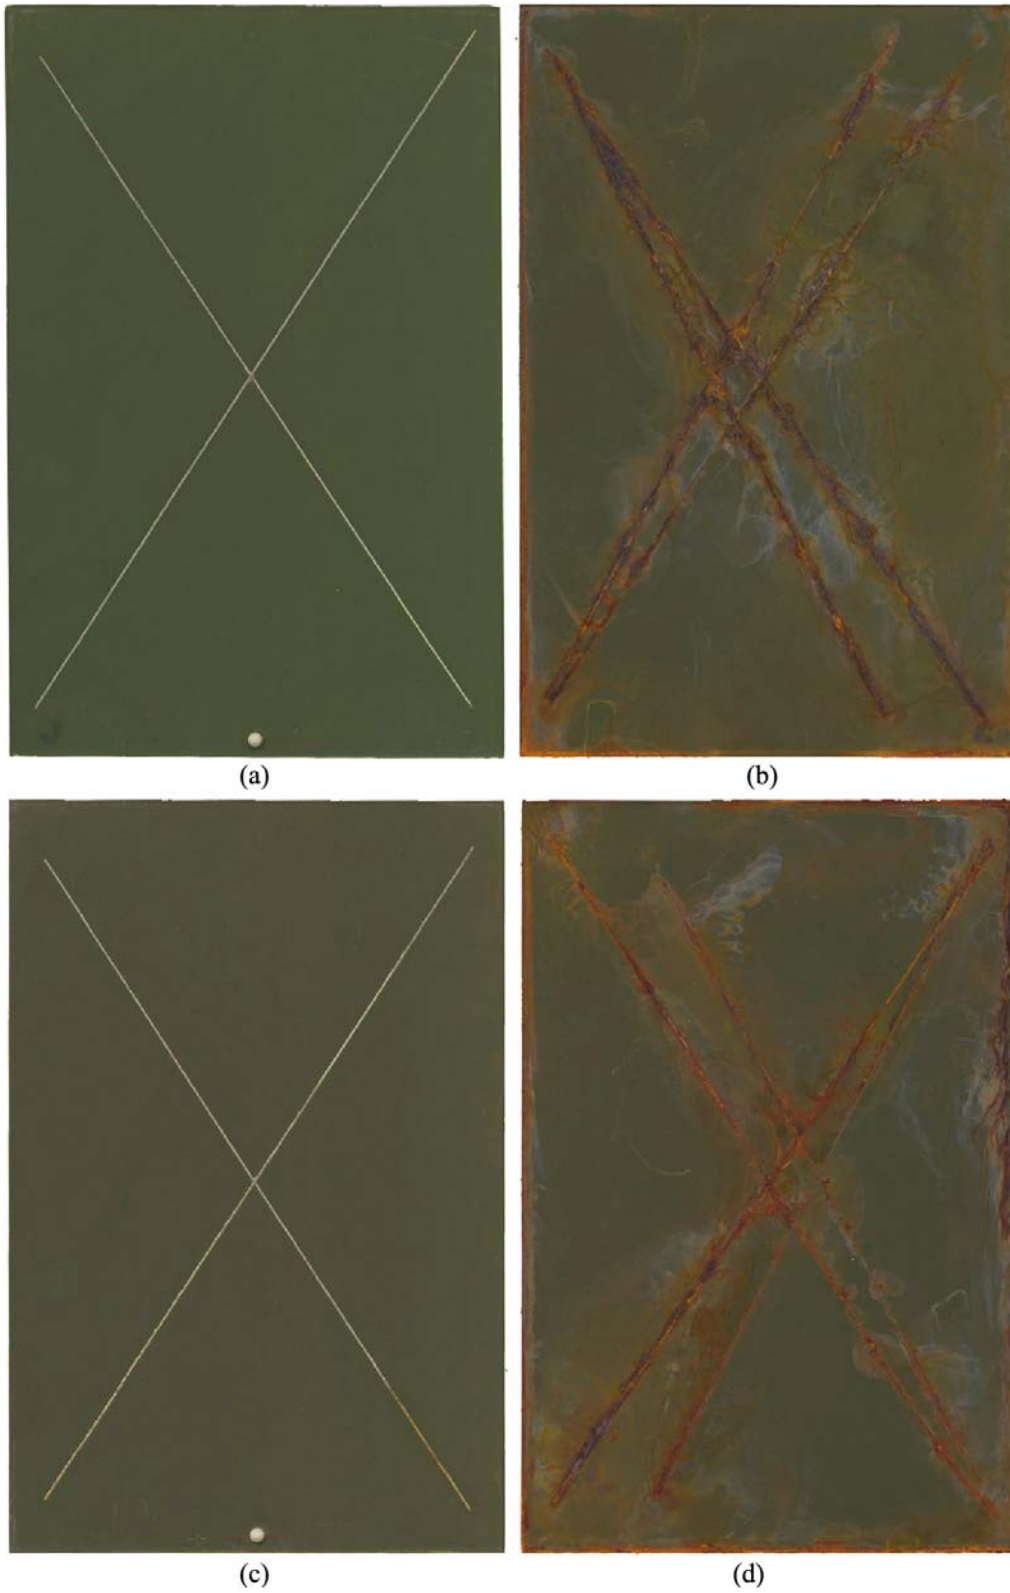
Figure 11. The 10-cycle GM 9540P results for scribed crevice corrosion showing relative corrosion severities for coating systems (a) 1, (b) 2, (c) 3, and (d) 4.

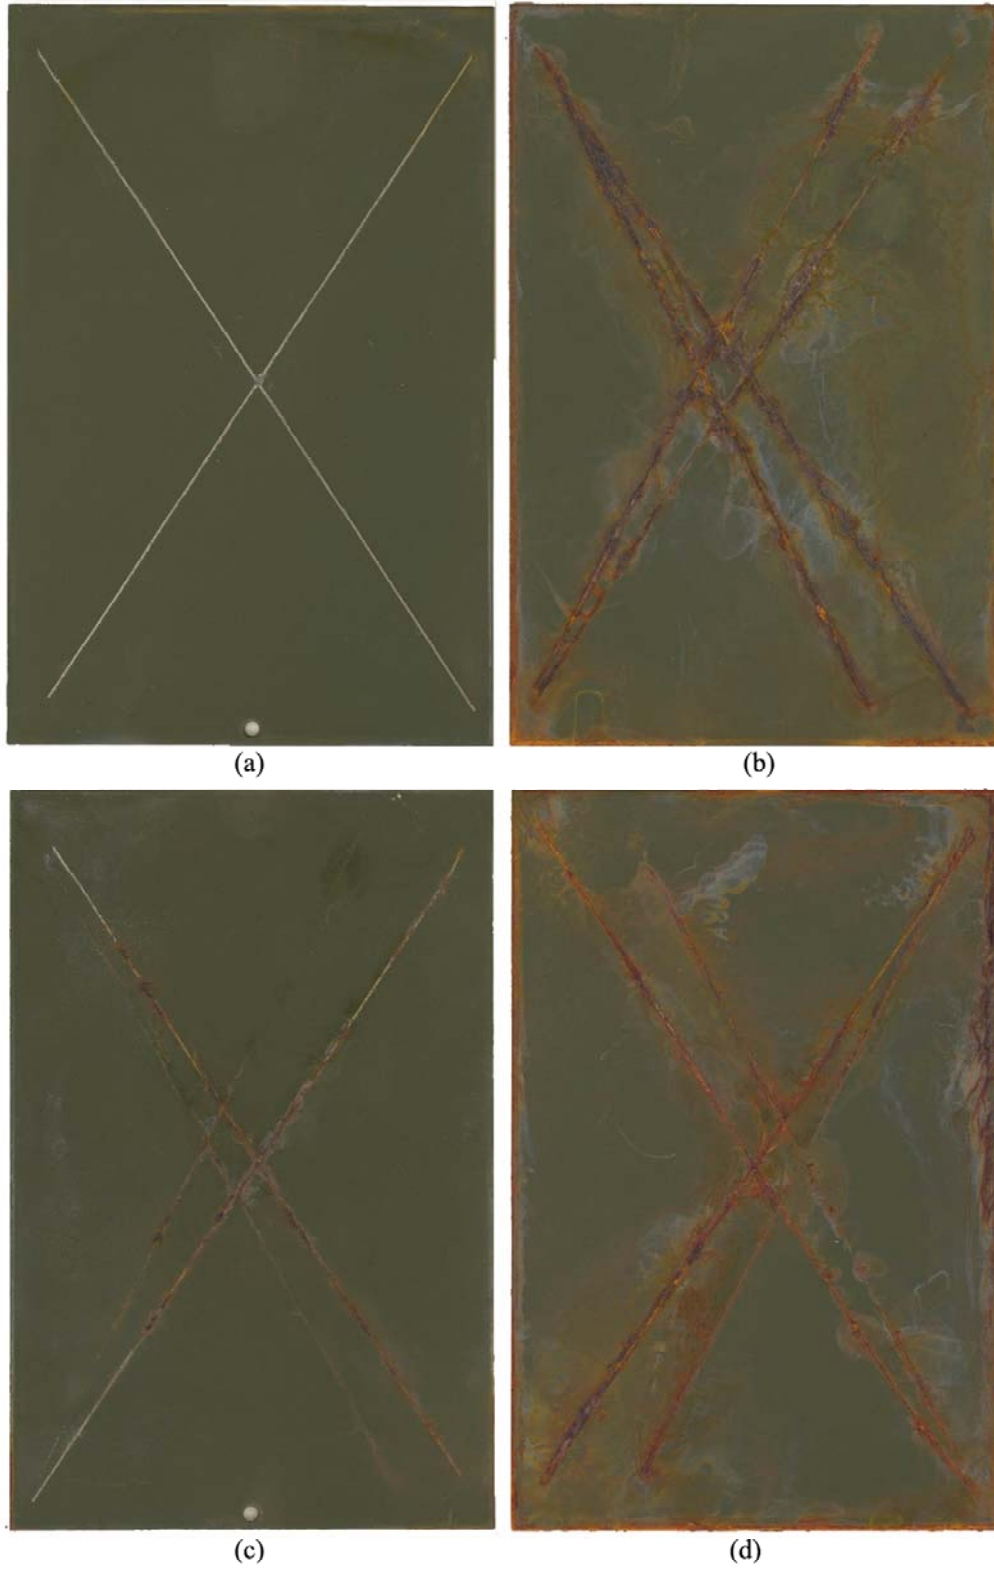
Figure 12. GM 9540P scribed crevice-corrosion damage for (a) coating system 1 at 50 cycles, (b) coating system 2 at 10 cycles, (c) coating system 3 at 50 cycles, and (d) coating system 4 at 10 cycles.

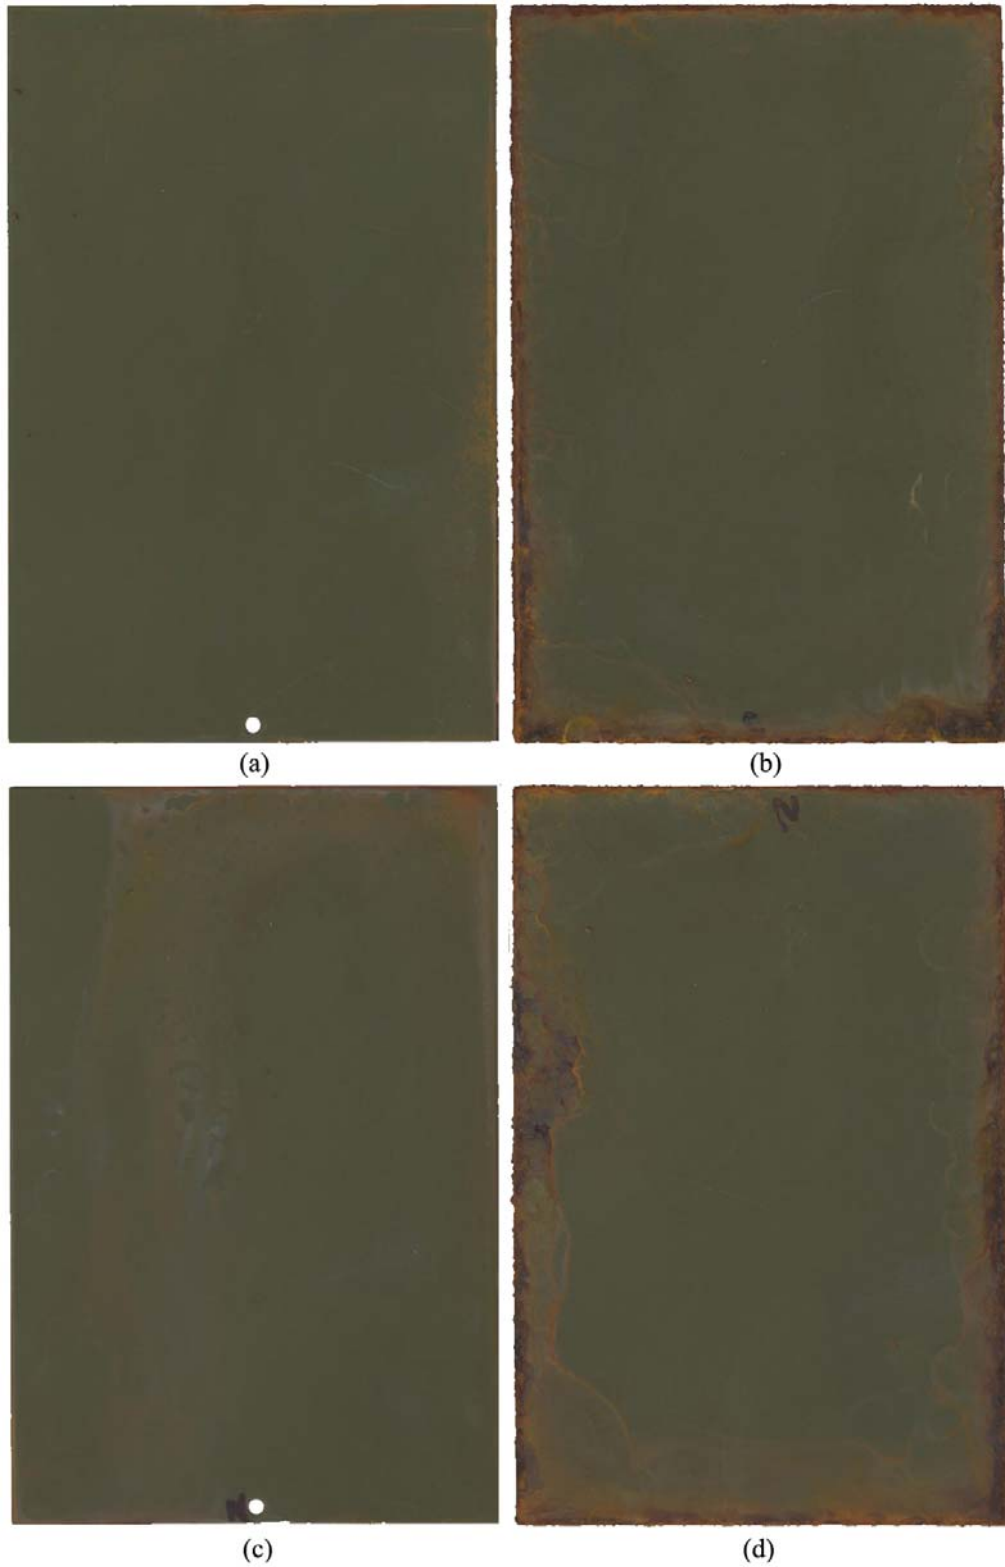
Figure 13. The 60-cycle GM 9540P results for unscribed crevice corrosion showing relative corrosion at the edges for coating systems (a) 1, (b) 2, (c) 3, and (d) 4.

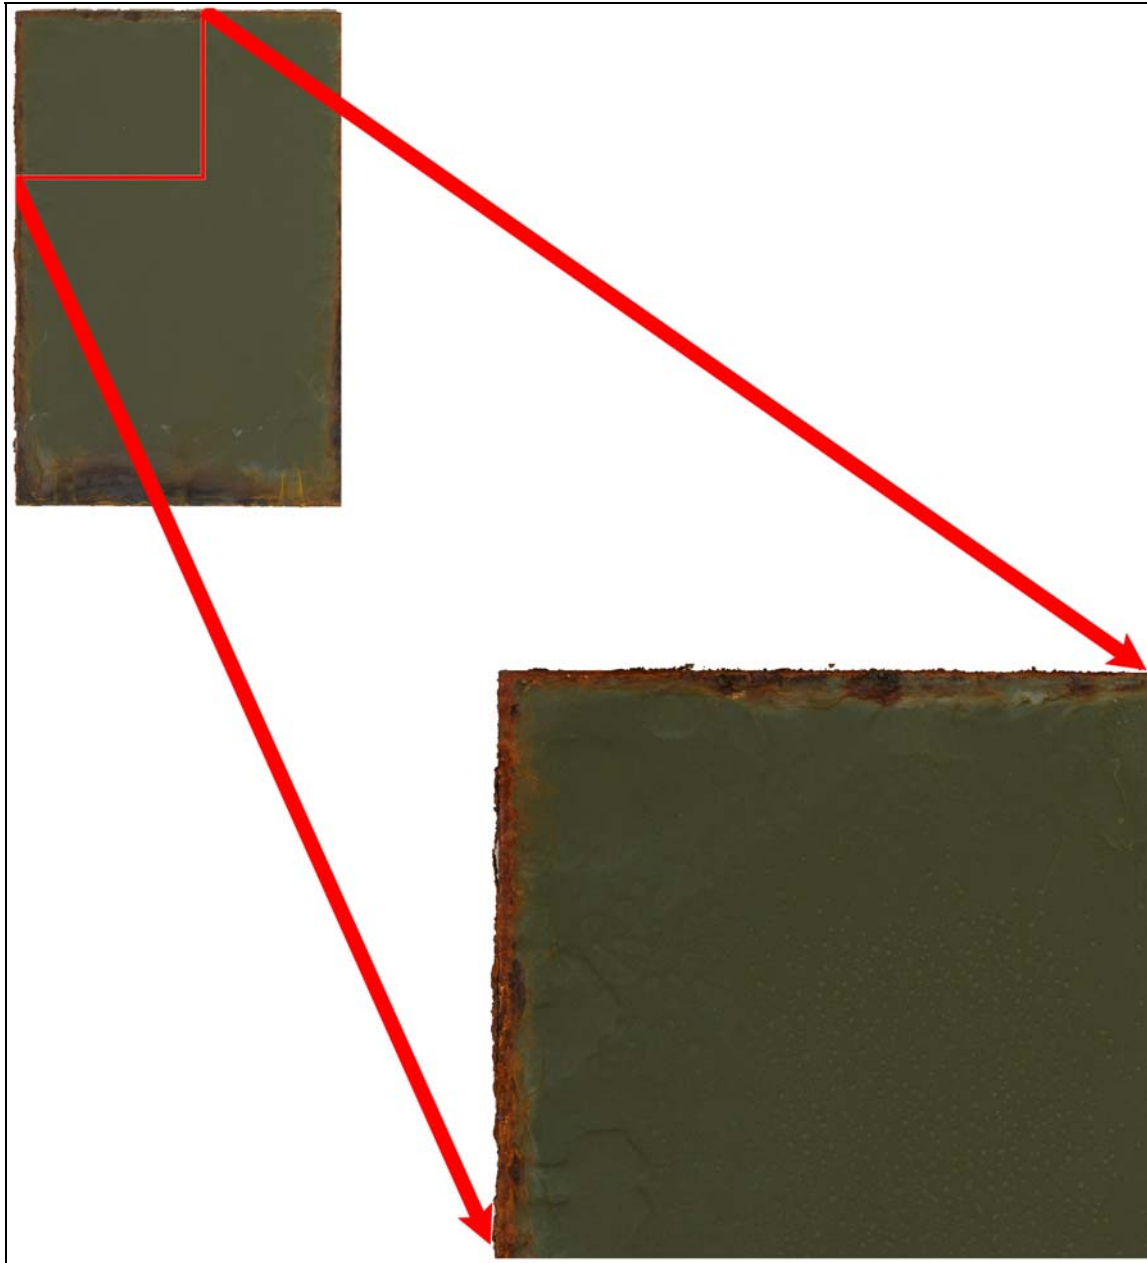
Figure 14. Unscrubbed crevice corrosion showing coating blistering (3 \times magnification) for coating system 2 after a 40-cycle GM 9540P exposure.

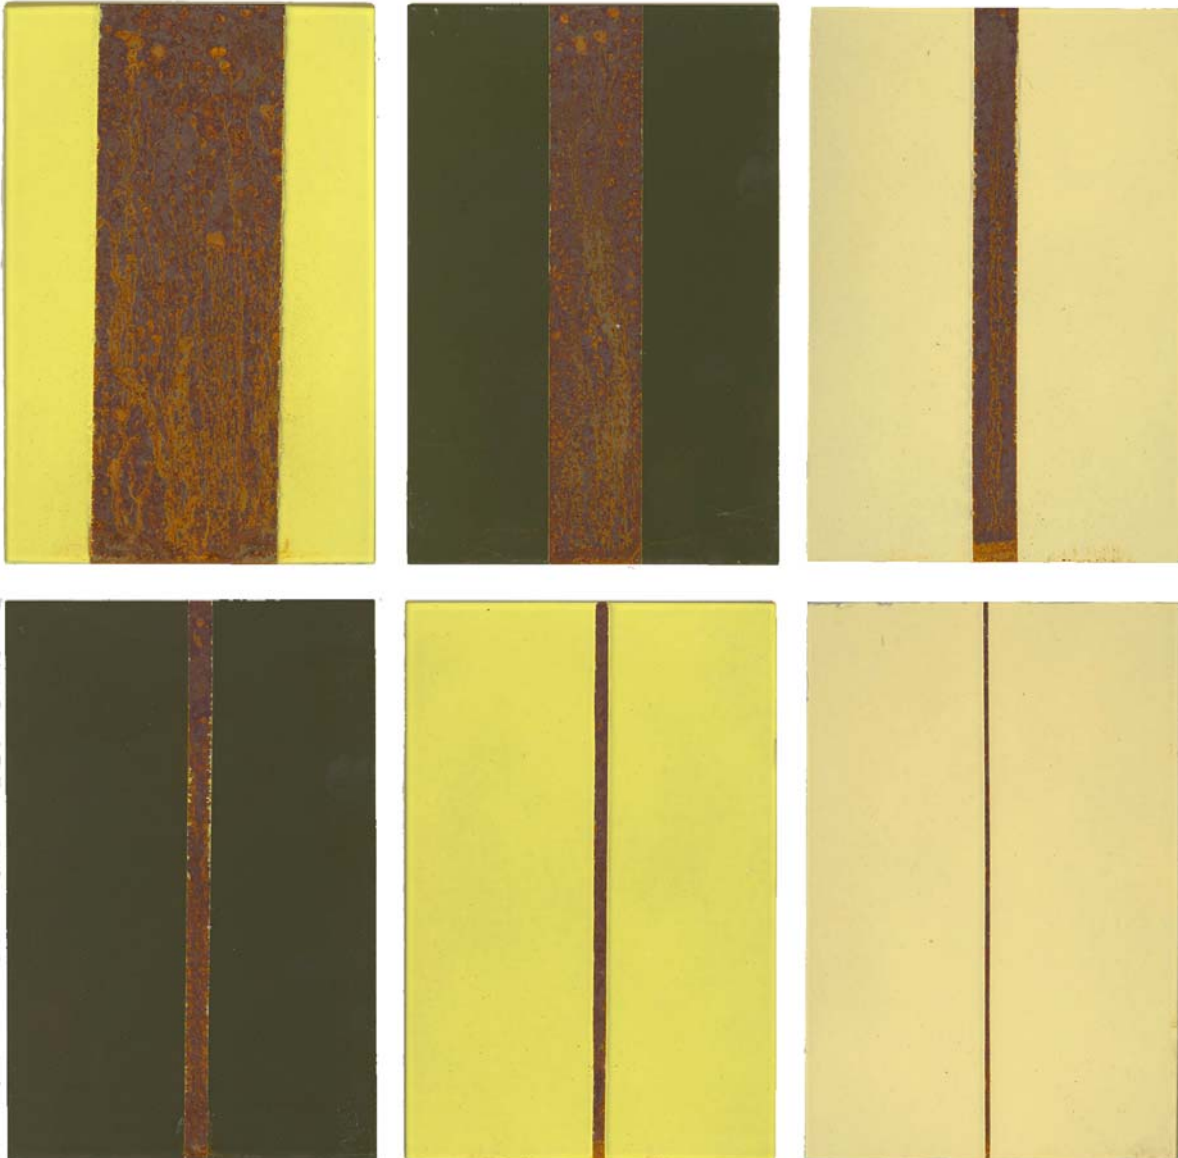
Figure 15. Cd-free throwing-power test panels terminated at less than one GM 9540P cycle.

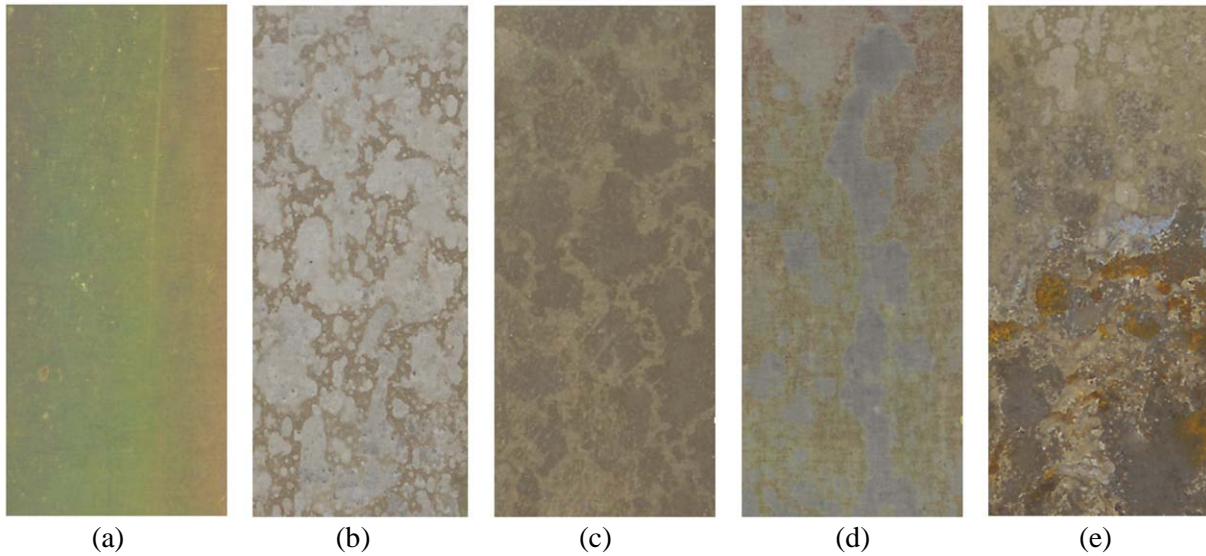
Figure 16. Magnification (5×) of the Cd-plating corrosion progression: (a) initial, (b) white Cd corrosion products and blotching, (c) dark gray to black blotches of oxidized Cd, (d) exposed areas of gray unruled steel or chromate-depleted Cd plating, and (e) rusting of steel substrate.

followed a basic sequence of steps. Initially, white Cd corrosion products and blotching formed, followed by dark gray to black blotches of oxidized Cd, followed by growing exposed areas of gray unrusted steel or chromate-depleted Cd, and, finally, red rust. Figure 16 shows the five steps in the Cd-plating corrosion progression. Tables 16 and 17 show the complete GM 9540P red-rust data for Cd-plated throwing-power specimens (all masked widths), with and without topcoats.

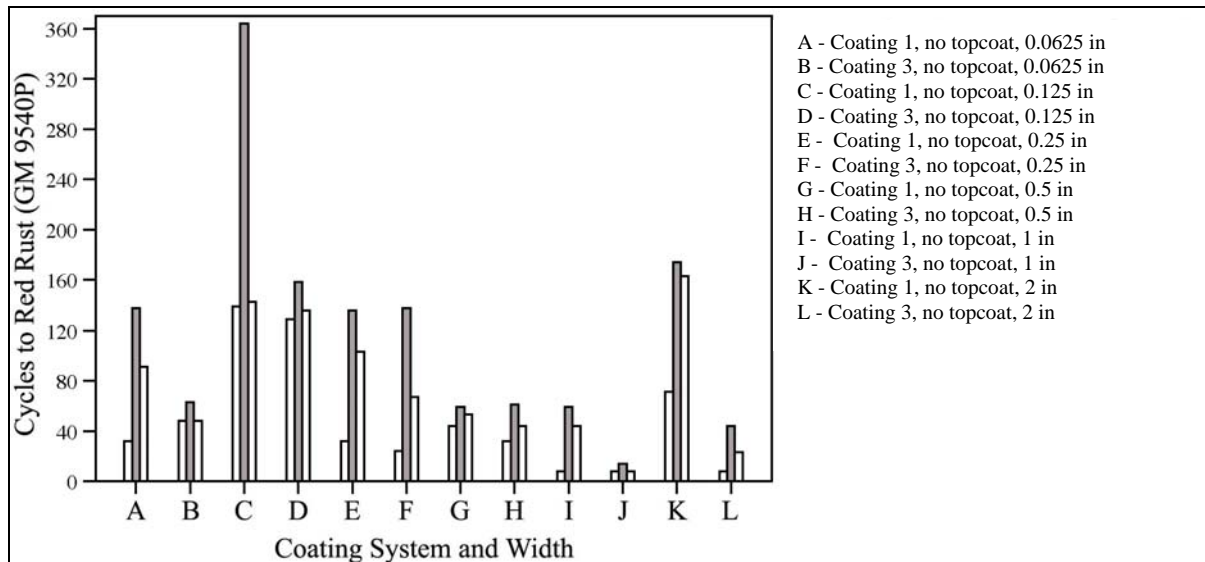
Figure 17. Coating system and throwing-power masked-area width (no topcoat) vs. GM 9540P cycles to red rust.

In an attempt to detect trends among the Cd-plated throwing-power sets, bar graphs (figures 17 and 18) were plotted using the three median values for the five replicates of each set. Examining the data reveals some interesting trends. When chromated primer is topcoated, much of the primer layer's benefit is negated, as seen when comparing the primed and topcoated 2-in bare-stripped chromated-primer panels against those with primer only. Among the topcoated panels, there seemed to be no clear difference between chromated and nonchromated panels. The chromate-primer topcoated panels performed better at 0.0625-, 0.25-, and 0.5-in uncoated stripe widths, while the nonchromate-primed panels performed better at 0.125-, 1-, and 2-in

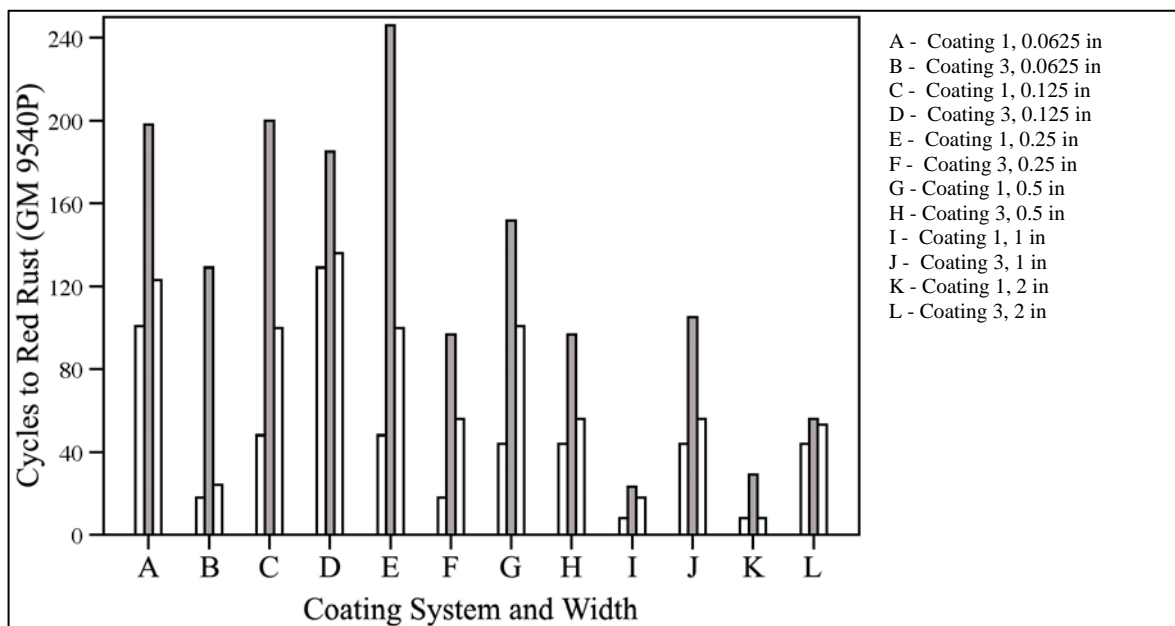
Figure 18. Coating system and throwing-power masked-area width vs. GM 9540P cycles to red rust.

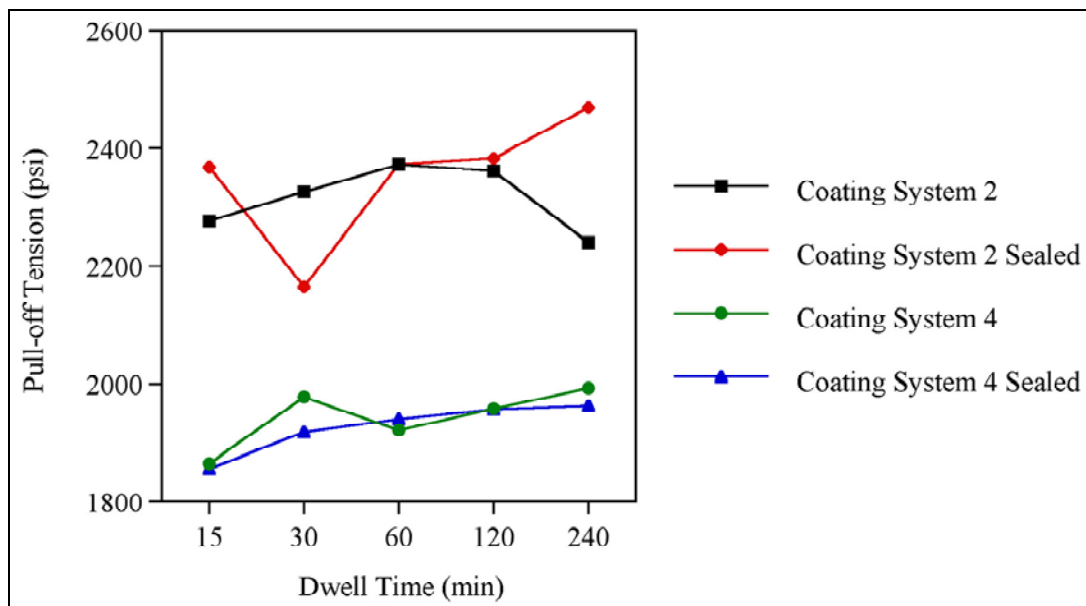
Figure 19. Average pull-off tensions vs. dwell time for abrasive-blasted Cd-free systems.

failure modes. While the vast majority of the pull-off failures were cohesive within the primer layer, there were occasional instances of adhesive failure between the topcoat and primer and between the primer and the substrate. Introducing nitrogen-sealed packaging produced little or no difference. Adhesion averages between unsealed and sealed counterparts were mixed. Average adhesion values for open-air or nitrogen-sealed exposure times showed a mainly upward trend (plotted in figure 19). For the smoother surface, Cd-plated and unplated,
